Re: Property-Specific Remedial Action Report  
Newhall Street Neighborhood  
91 Marlboro Street, Block K  
Hamden, Connecticut 06517

**PROPERTY-SPECIFIC REMEDIAL ACTION REPORT  
91 MARLBORO STREET**

**NON-PUBLIC PROPERTIES  
NEWHALL STREET NEIGHBORHOOD  
HAMDEN, CONNECTICUT**

**AMEC Project Number: 6107110004/95**

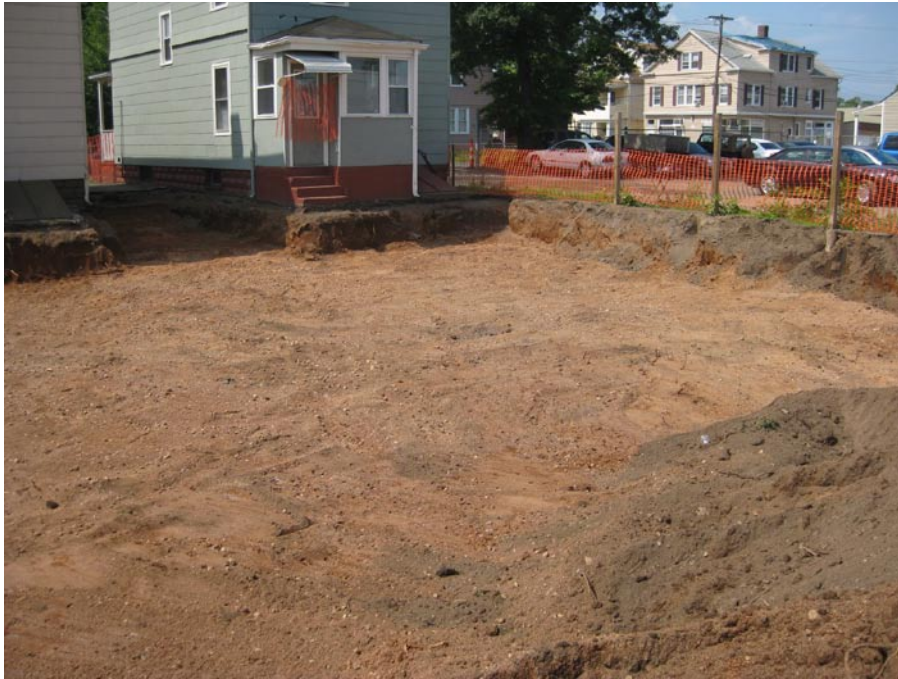
**View looking Southwest at full excavation area**

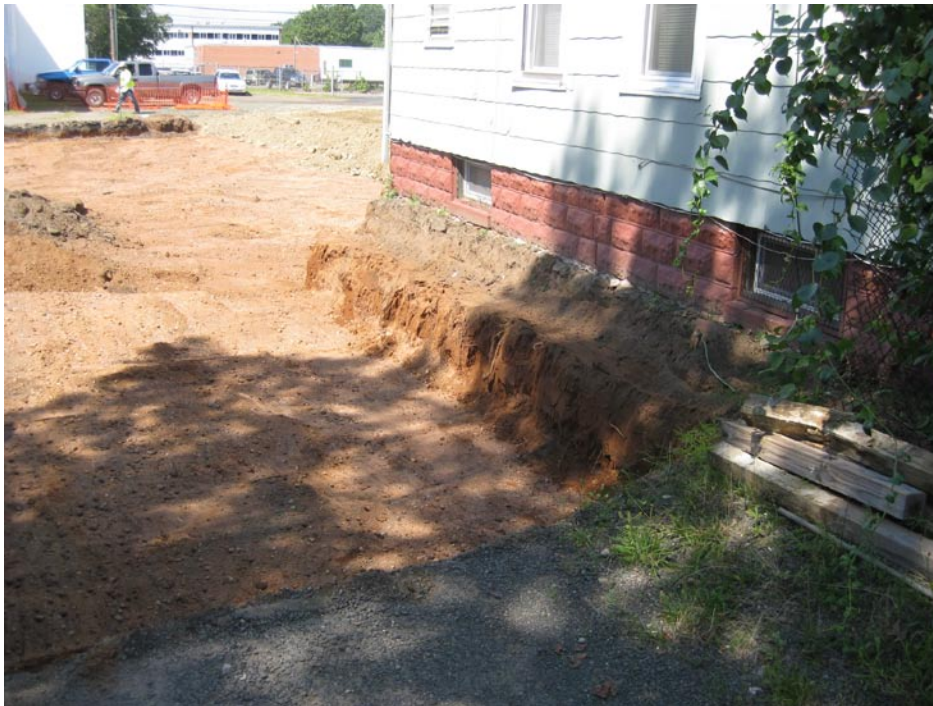
**View looking Northeast at edge of excavation in driveway**

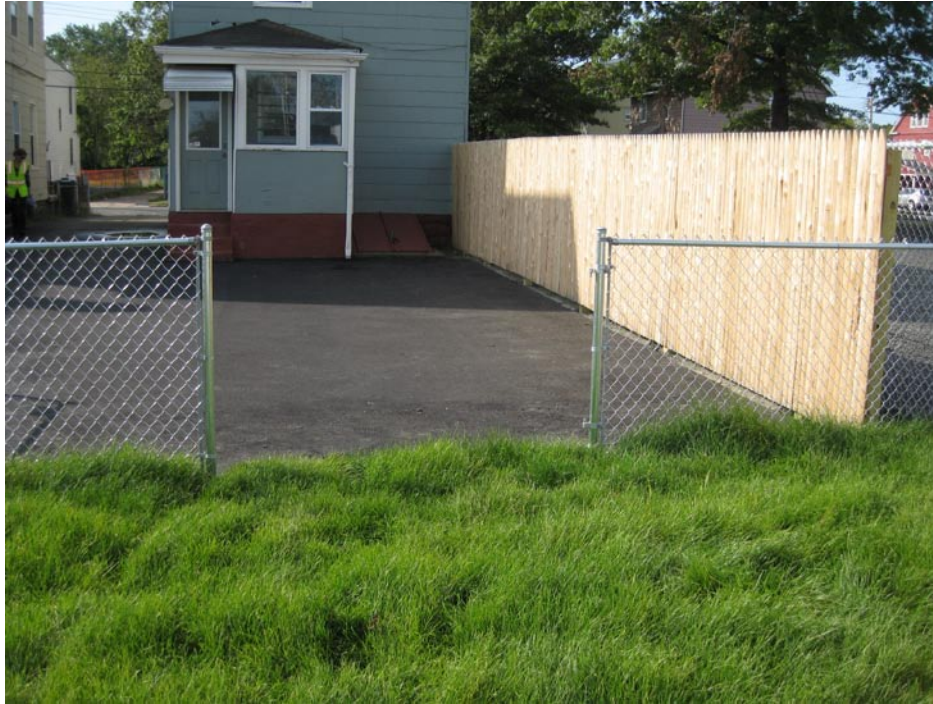
**View looking South at restored driveway and parking area**

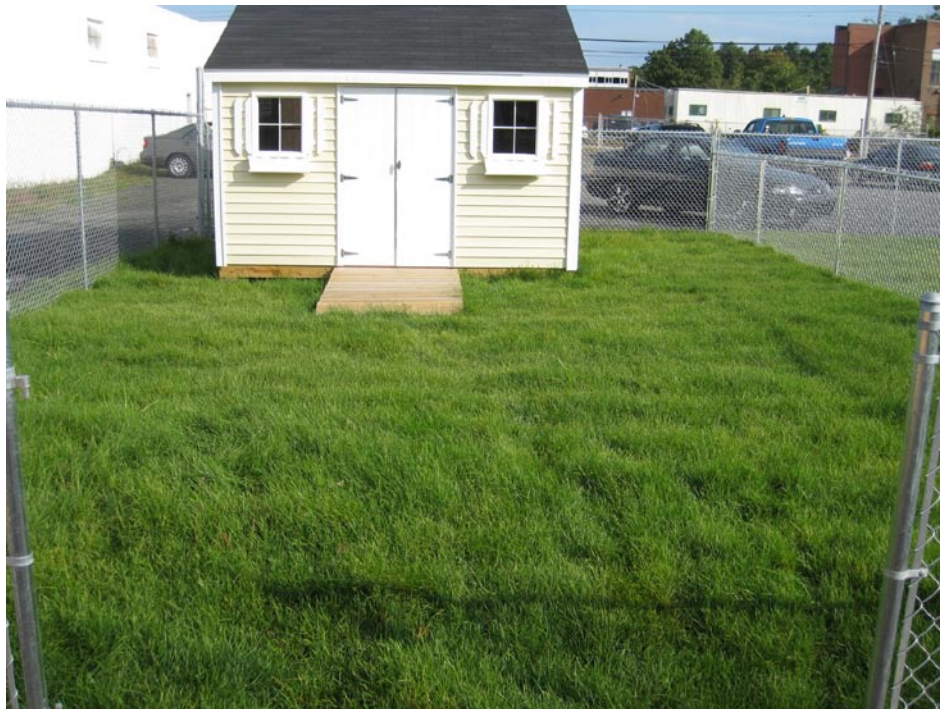
**View looking North at newly installed shed**
